Memorandum

Subject: Initial Sampling Recommendations for COPC List Development for the Barclay Street

Property

The Barclay, 300 South Barclay Street, 189 East Oregon Street, Milwaukee, Wisconsin

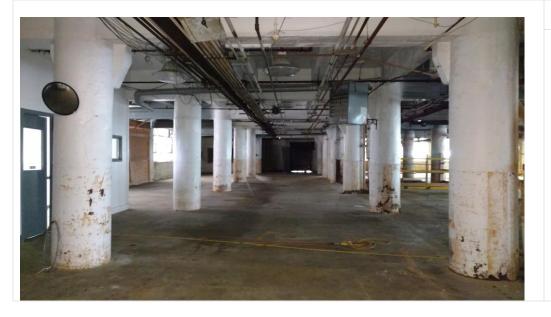
PHOTOGRAPH 15:

sampled separately, e.g. the wood ceiling noted above. Based on the photographs, we recommend sampling the materials listed in Table 1. When selecting locations, we recommend sampling areas of discoloration or pigment. For example, Photo 15 has a discolored area on the floor directly under the pipe run; it is not possible to tell if that is just moisture or represents staining of some sort.

Building 11, First Floor Concrete floor Brick and window walls Concrete and steel columns Concrete ceiling
